PUBLIC NOTICE

IDEM ID Number: 2010-232-22-DDC-A

Corps of Engineers ID Number: LRL-2010-552-kjs

The proposed project is to construct a commercial development site. In order to do so, the applicant proposes impact approximately 0.091 acre of forested, 0.057 acre of scrub-shrub, and 0.603 acre of emergent wetlands with the discharge of clean earthen fill from the project site. In addition, the applicant proposes to impact approximately 155 linear feet of three ephemeral tributaries with the discharge of 20 cubic yards of clean earthen fill. The applicant shall impact approximately 0.53 acre of open water with the placement 340 cubic yards of clean fill. As compensatory mitigation for impacts, the applicant proposes to construct 1.33 acres of emergent and 0.13 acre of forested wetland, establish a 50 foot wide wooded riparian corridor along 820 linear feet of Jacobs Creek, and create 0.11 acre of open water. For additional information: http://www.in.gov/idem/5474.htm

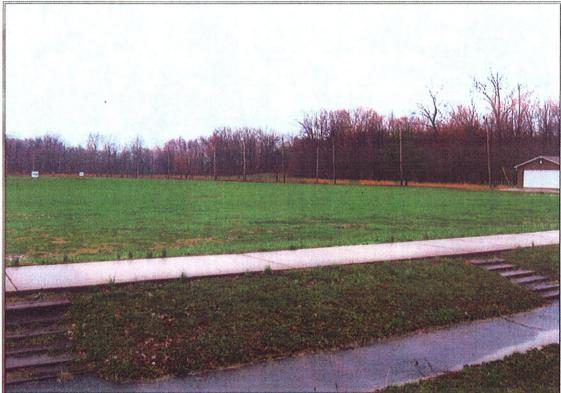
Photograph 1: General view of northwestern portion of the site where golf range was operated, looking southeast. Charlestown Road Property. March 31, 2008.

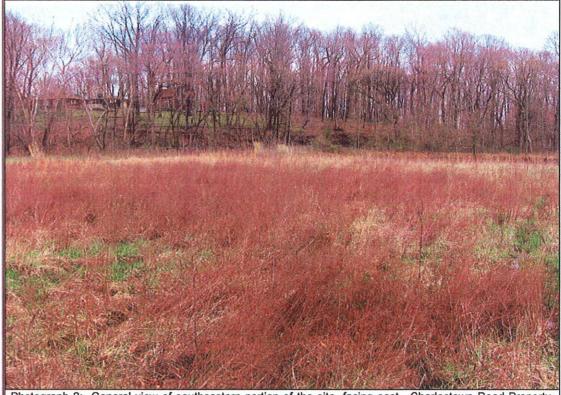
Photograph 2: General view of southeastern portion of the site, facing east. Charlestown Road Property. March 31, 2008.

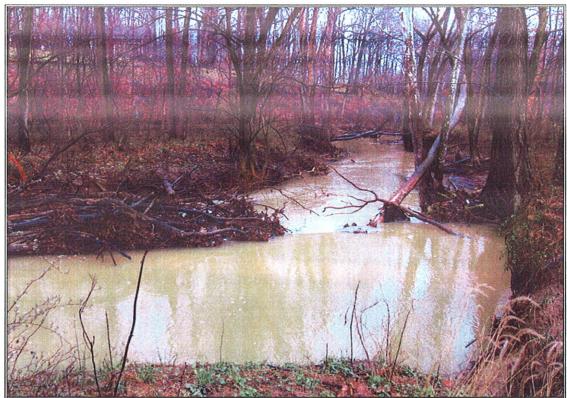
Photograph 3: View of Perennial Stream 1 (Jacobs Creek), looking upstream along the eastern portion of the site. The stream had vertical eroding banks along many reaches of the stream and had a narrow riparian corridor along the right bank. Charlestown Road Property. March 31, 2008.

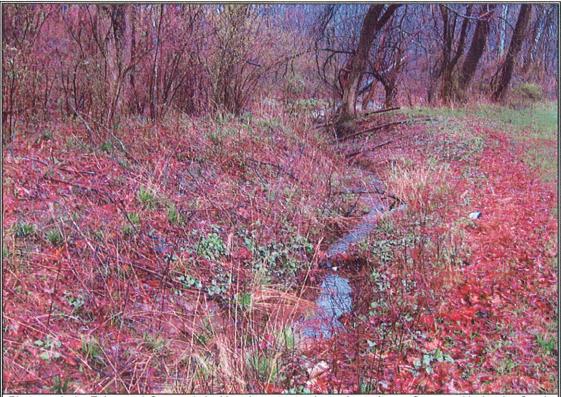
Photograph 4: Ephemeral Stream 1, looking downstream, just prior to its confluence with Jacobs Creek. Charlestown Road Property. March 31, 2008.

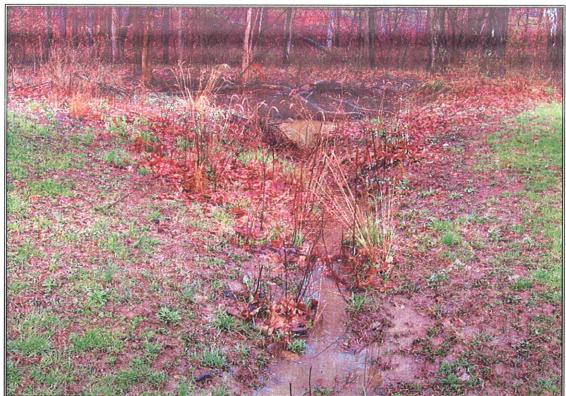
Photograph 5: View of Ephemeral Stream 3, looking downstream, just prior to it confluence with Perennial Stream 1 (Jacobs Creek). The stream lacks a wooded riparian corridor, diversity of substrate and was vegetated through most of the stream channel. Charlestown Road Property. March 31, 2008.

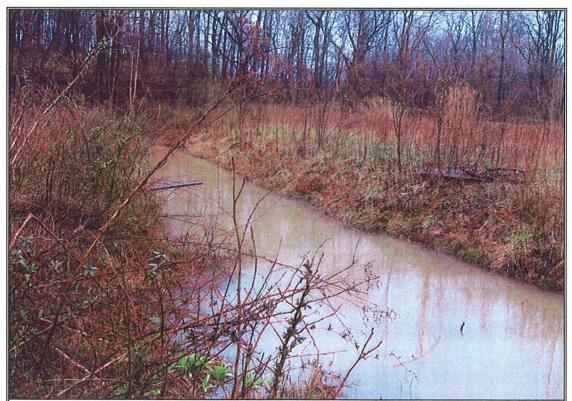
Photograph 6: Ephemeral Stream 4 appears to be a manmade channel that contains Wetland 1 throughout much of the manmade drainage feature and Ephemeral Stream 4 in the lower approximately 60 feet. The stream has been dammed up by beaver activity just prior to its confluence with Jacobs Creek. Charlestown Road Property. March 31, 2008.

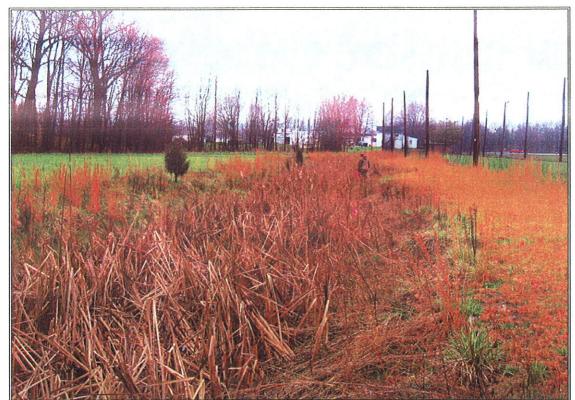
Photograph 7: Wetland 1 is located in what appears to be a manmade channel that runs southeast in the western portion of the property and then runs east towards Jacobs Creek. Charlestown Road Property. March 31, 2008.

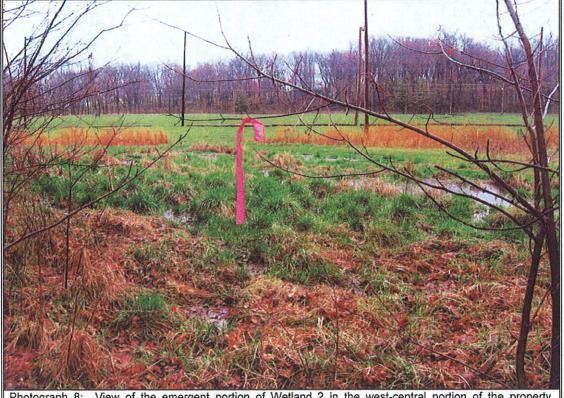
Photograph 8: View of the emergent portion of Wetland 2 in the west-central portion of the property. Charlestown Road Property. March 31, 2008.

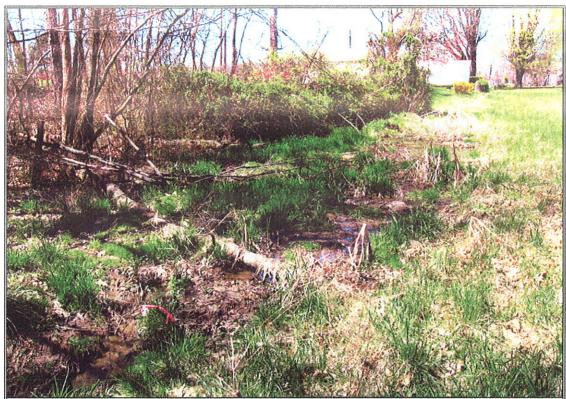
Photograph 9: View of Wetland 8 in the northwestern portion of the project site. Charlestown Road Property. April 15, 2008.

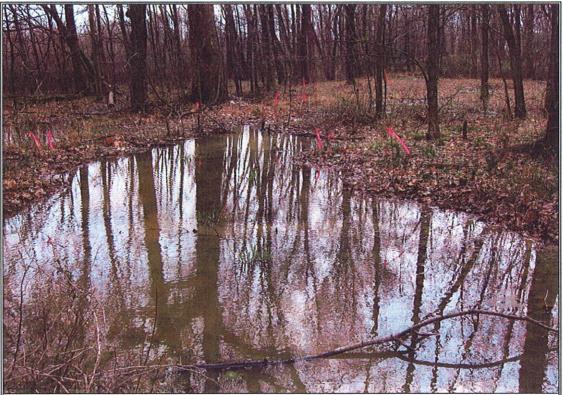
Photograph 10: Wetland 6 is located in the southwest corner of the property. It receives water that overflows from Open Water 1. Charlestown Road Property. March 31, 2008.

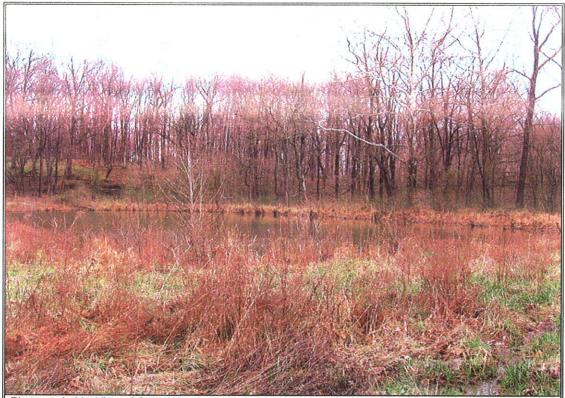
Photograph 11: View of Open Water 1 in the southern portion of the property. Charlestown Road Property. March 31, 2008.

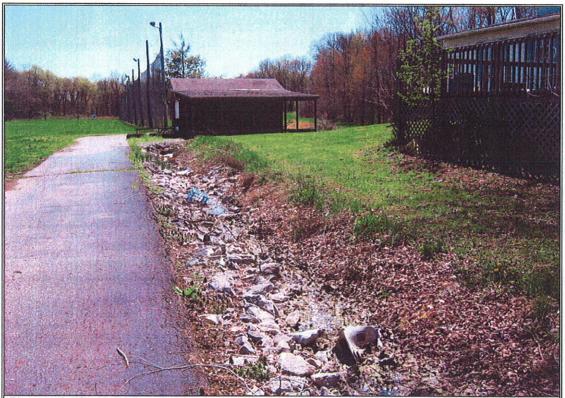
Photograph 12: View of manmade drainage ditch that transports stormwater run off through the western portion of the property. The ditch flows through a culvert that is located under the small building and then flows into Wetland 1. Charlestown Road Property. April 15, 2008.
